SECTION 6:

TROUBLESHOOTING & SELF-DIAGNOSTICS

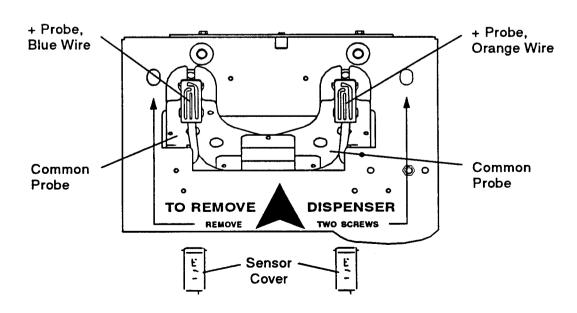
Figure 6-1 Sensor Check

- 1. Switch the Bill Changer power OFF at the electrical box.
- 2. Remove the black plastic cover from the phototransistor and connect a common meter lead to the metal dispenser backing plate as shown in Figure 6-1.
- 3. Connect the positive (+) meter lead to the blue wire (Figure 6-1, Sensor Check-Blue Wire).
- 4. Turn the power switch ON and check to see that the LED is lit. The meter should indicate between 4.7 and 5.2 VDC.

5. Move the + meter lead to the orange wire on the phototransistor as shown in Figure 6-1, Sensor Check - Orange Wire. The meter should indicate between 3.5 and 5.0 VDC.

If the meter indication is not correct (between 4.7 and 5.2 VDC), the voltage regulator on the CCC board may need replacement (see Section 7). Repair the malfunction before continuing this procedure.

If the voltage is less than 3.5 volts, replace the phototransistor board with the correct part number listed in Section 8: PARTS CATALOG.
